ERDC/SL TR-00-6

Ultimate Deflection Response of Lightly Reinforced Concrete Intake Towers

Richard C. Dove

August 2000

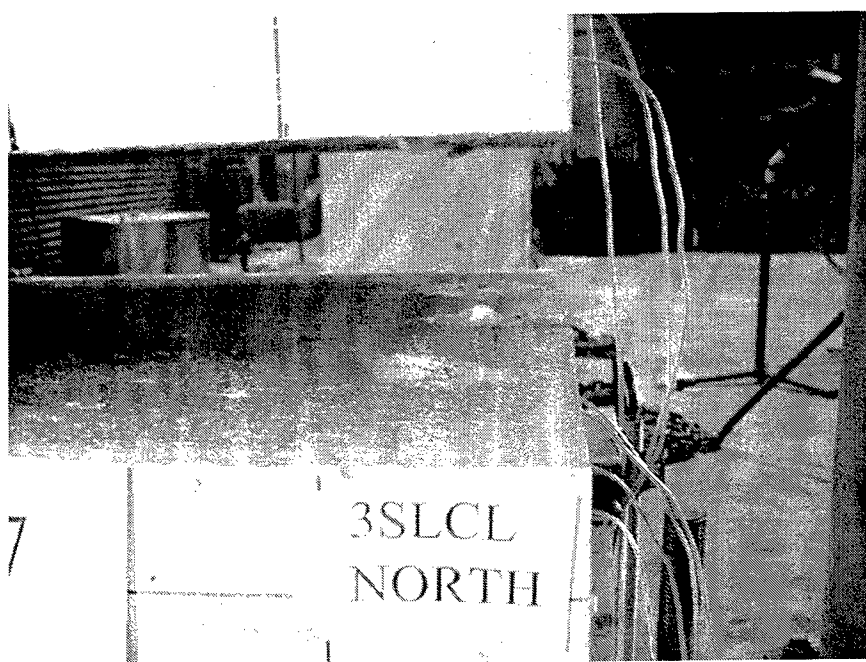
Figure 14. Closeup view of 3SLCL failure plane

The experiment 3SLCL was conducted on 27 December 1998. Figure 13 shows the model during loading. A single crack formed at the cold joint and failure occurred within the crack (Figure 14). The cyclic application of the vertical deflection loads proceeded through 18 cycles to initial failure during the third application of the 0.6-in. cycle. The total deflection at failure was 0.345 in., as measured by the average of four 40-in. and four 8-in. LVDT gages. The load-deflection curve is shown in Figure 15. Loading was continued until complete failure was reached. The apparent failure mode was a localized response of the rebar with no concrete degradation. There was only a small degree of very localized crushing of the concrete immediately around the rebar failure zone. This conical zone of crushed concrete extended about one bar diameter into the model above and below the cold joint. The reinforcing bar appeared to fail in tension. Some bending of the rebar was evident, caused by the compression of the rebar during the reverse loading cycles.

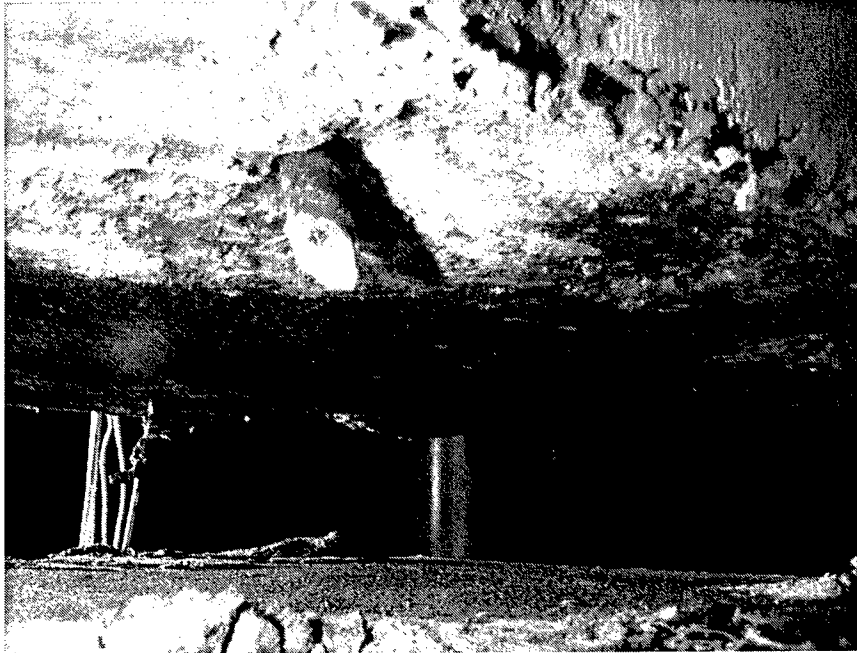
Figure 35. Closeup view of 5SLCH failure plane and rebar

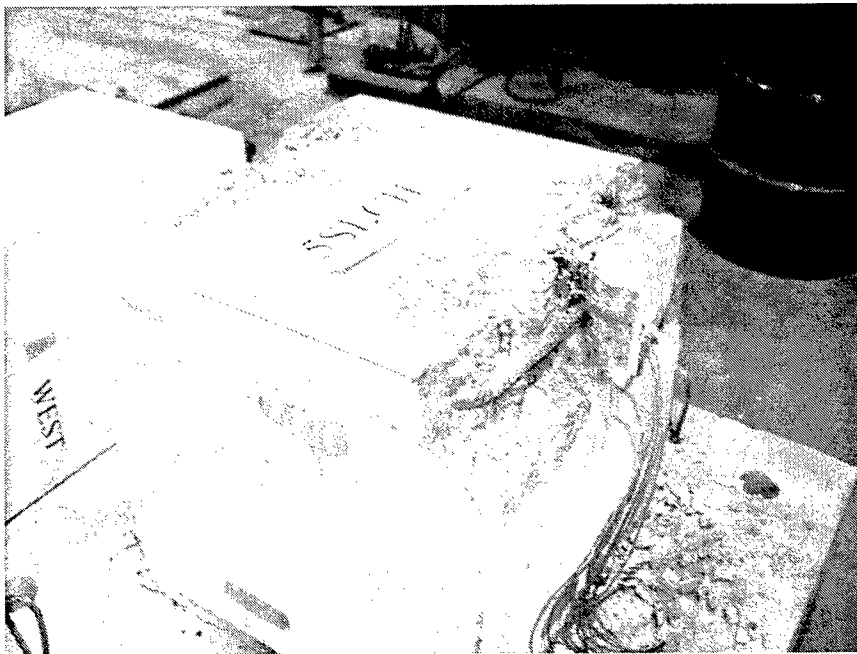
Figure 36. View of 5SLCH lower portion of failure plane with upper half removed

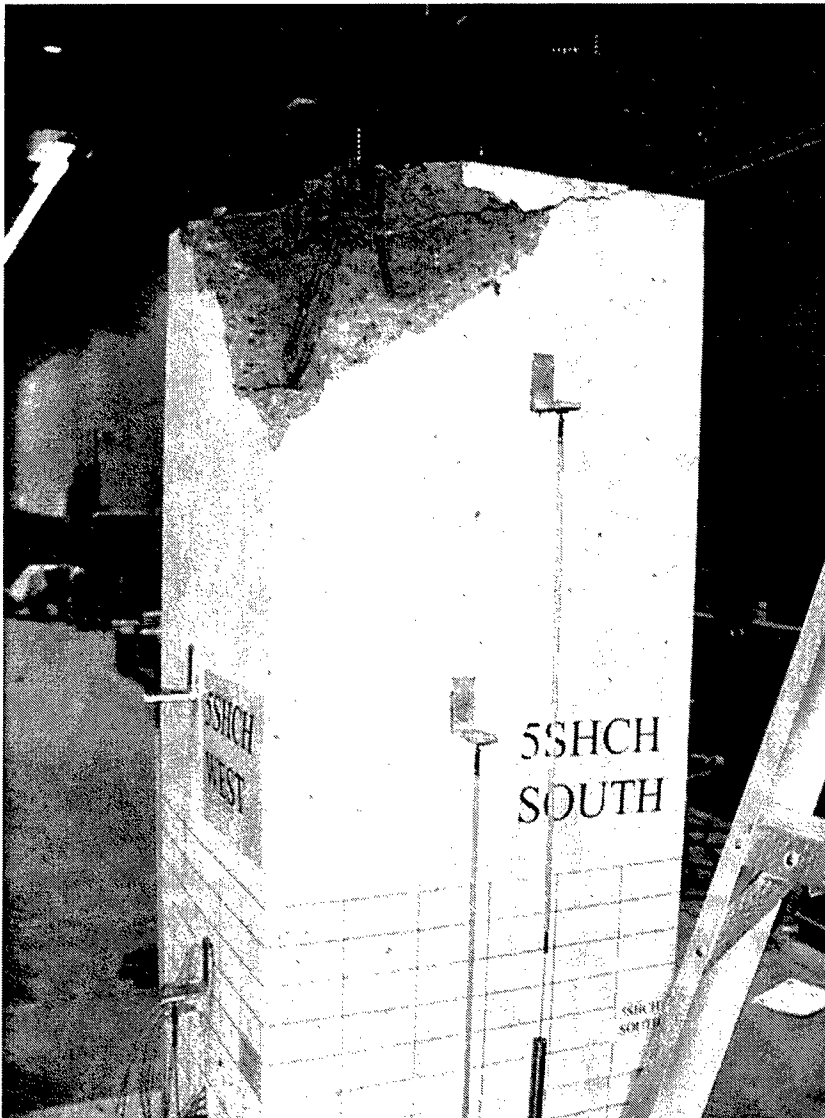
Figure 42. Damage to 5SHCH model due to accidental loading

upon application of the dead load to the model. As a result of this oscillation, one of the load plate bolt nuts vibrated down to contact the load plate. When the hydraulic system was shut down and then restarted, the ram violently rebounded upward about 2 in. pulling upward on the single bolt and failing one corner of the model (Figure 42). Fortunately no one was injured. An attempt was made to salvage the model by removing the damaged portion, replacing the lifting bolts, providing additional anchoring and replacing the concrete with very high strength grout (Figures 43 and 45). When an attempt was made to load the repaired model, failure occurred at the interface of the new and old concrete (Figure 46). This failure mode was obviously an artifact of the repairs made and the experiment was abandoned.
